# THE VANGUARD SATELLITE LAUNCHING VEHICLE - AN ENGINEERING SUMMARY \*

(Engineering Report No. 11022)

April 1960

THE MARTIN COMPANY, Baltimore, Md.

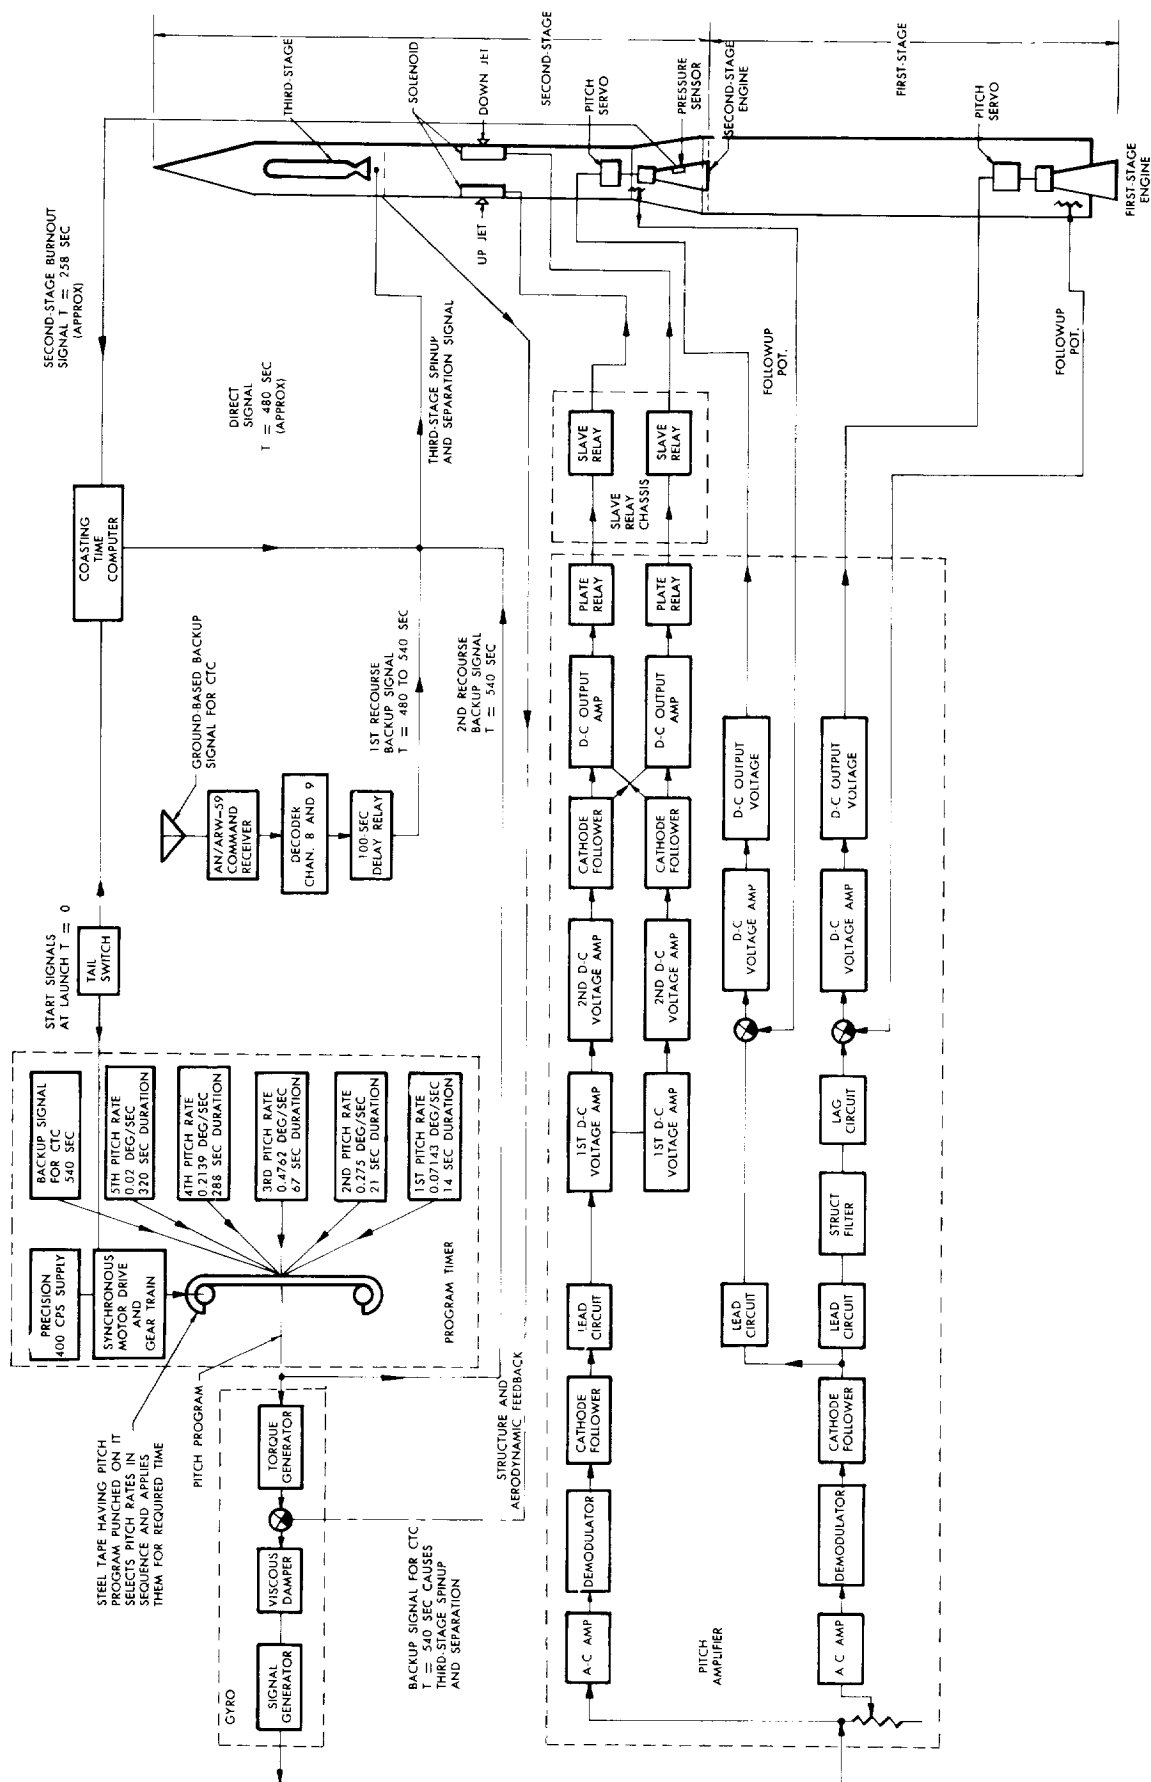
Fig. 14 Airborne Pitch Guidance and Control System

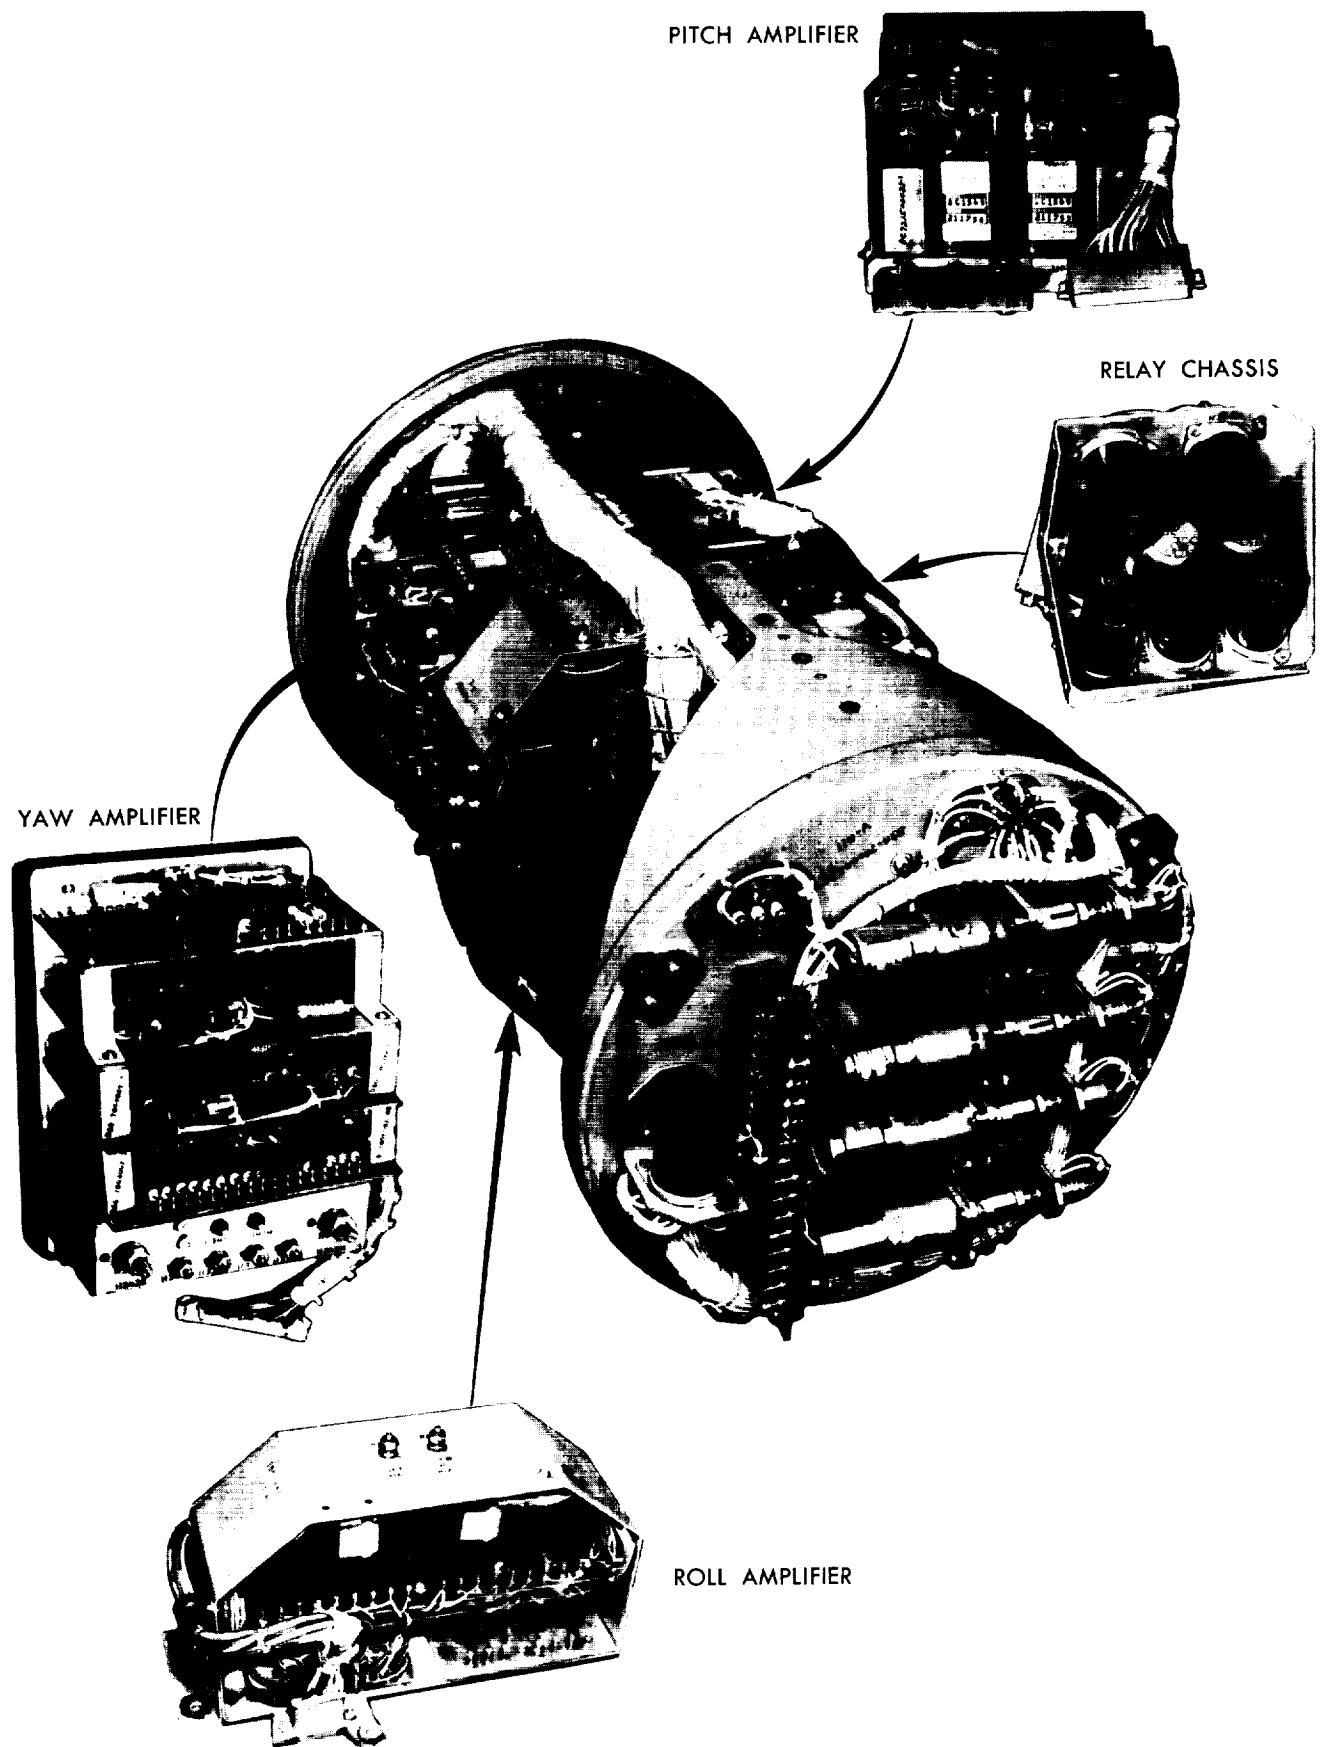
Fig. 15 Airborne Controls Can

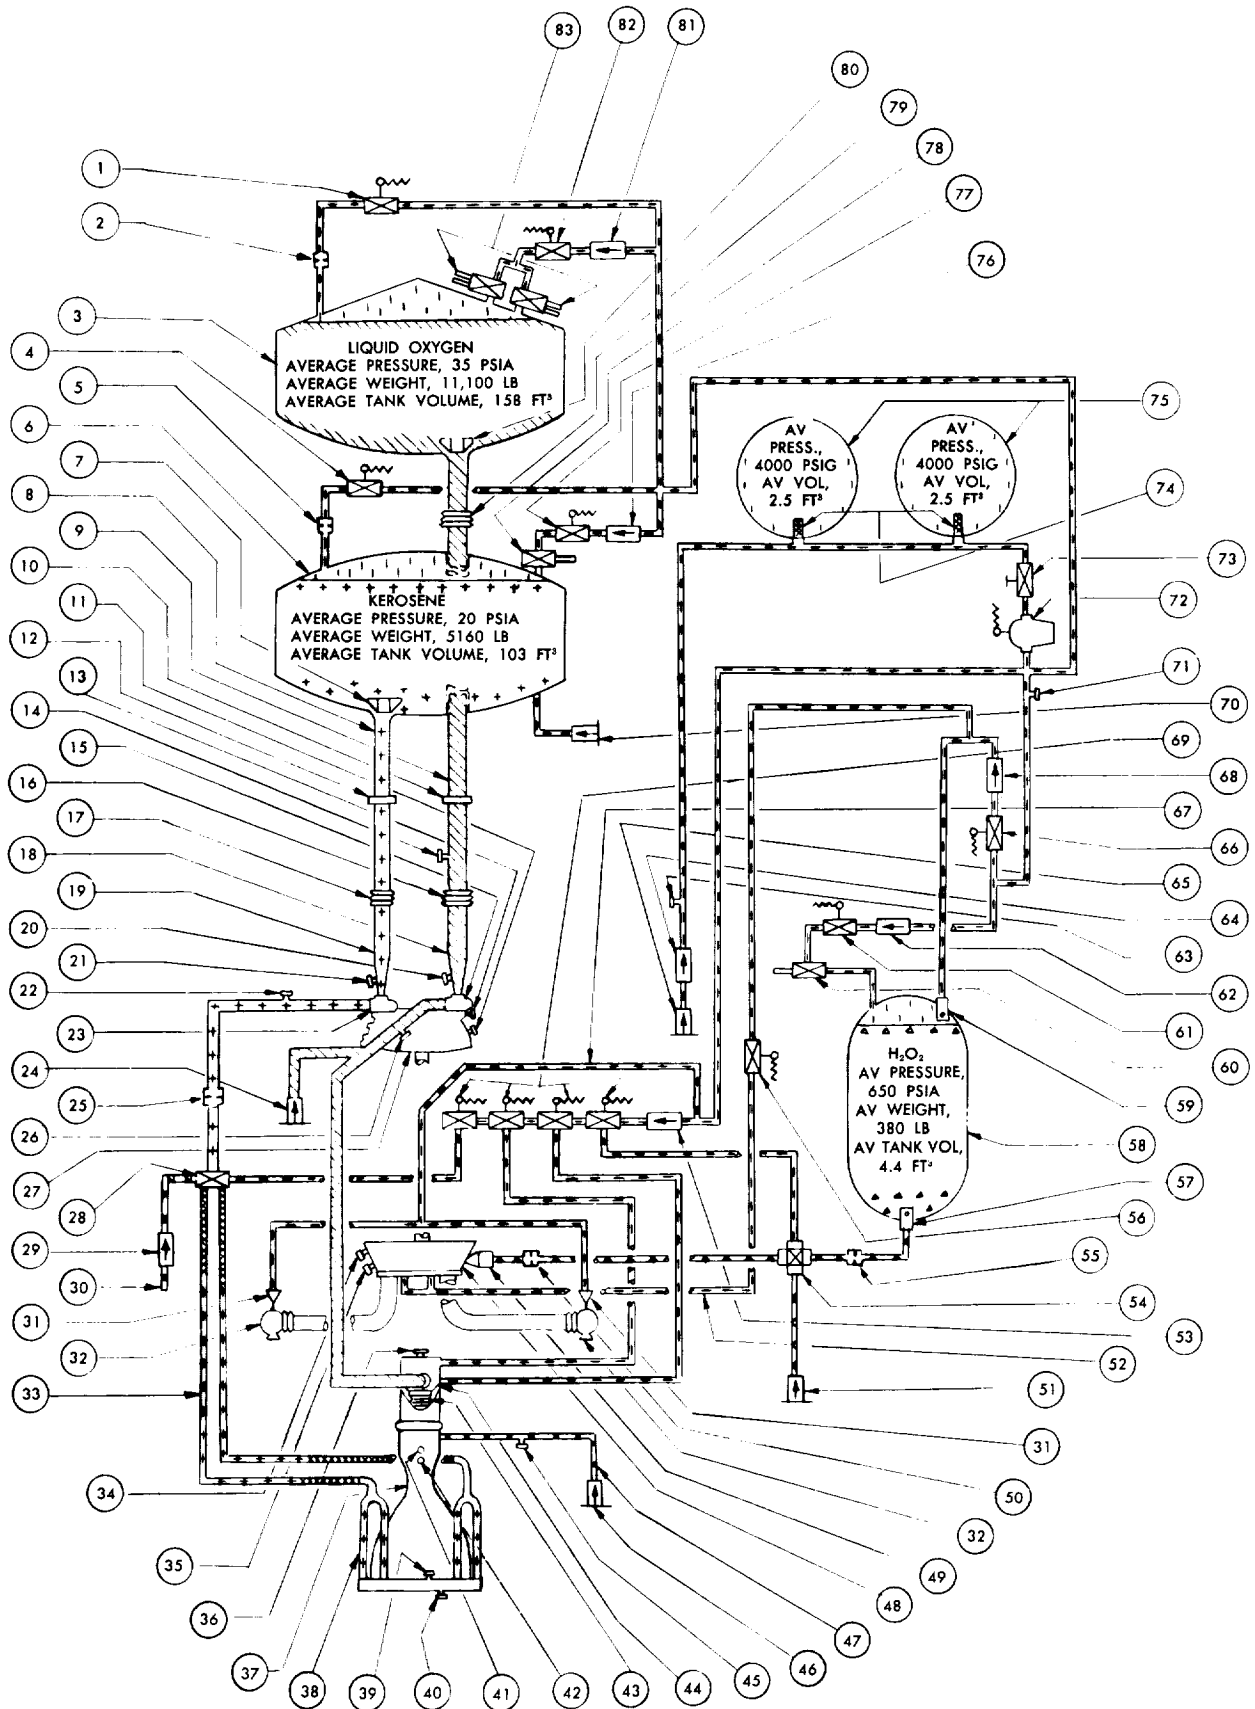
Fig. 16 First-Stage Propulsion System Schematic

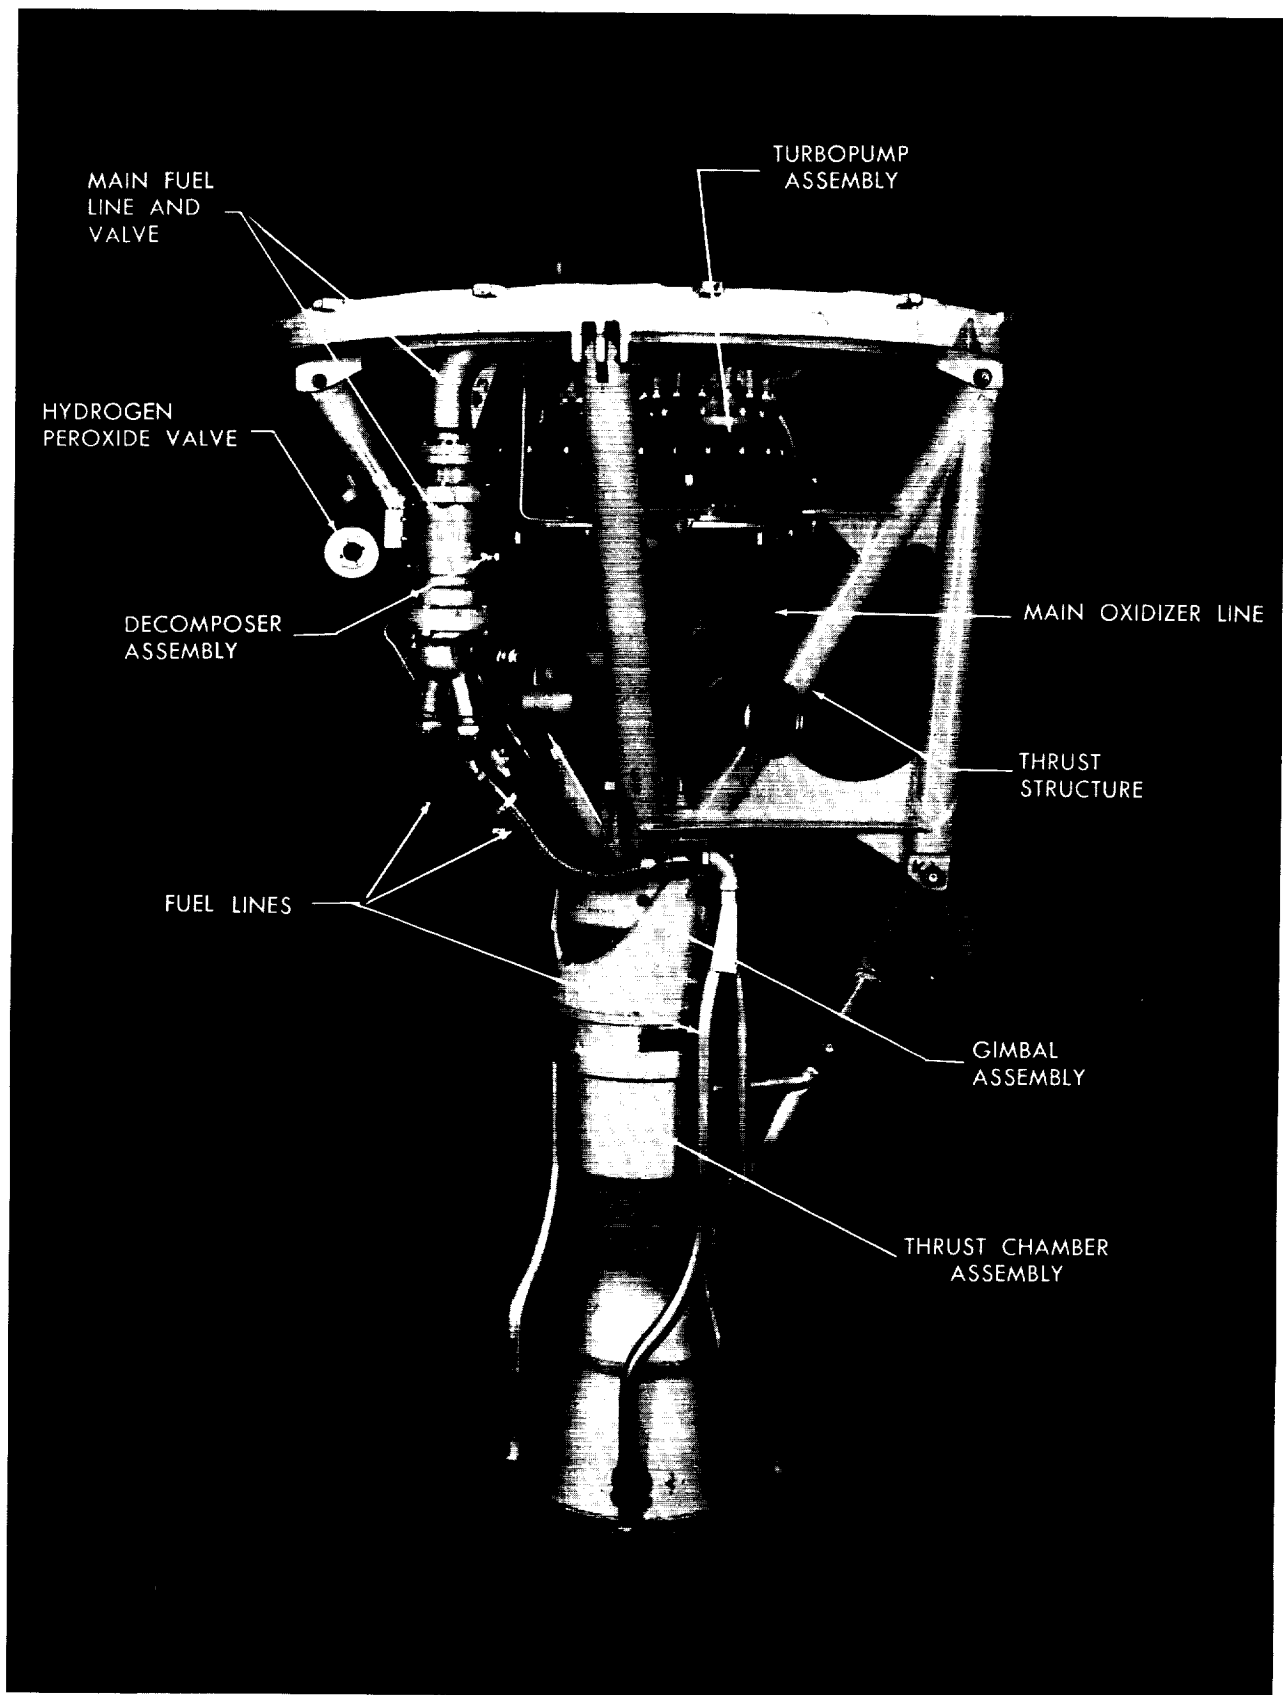
**Fig. 17 First-Stage Engine Package**

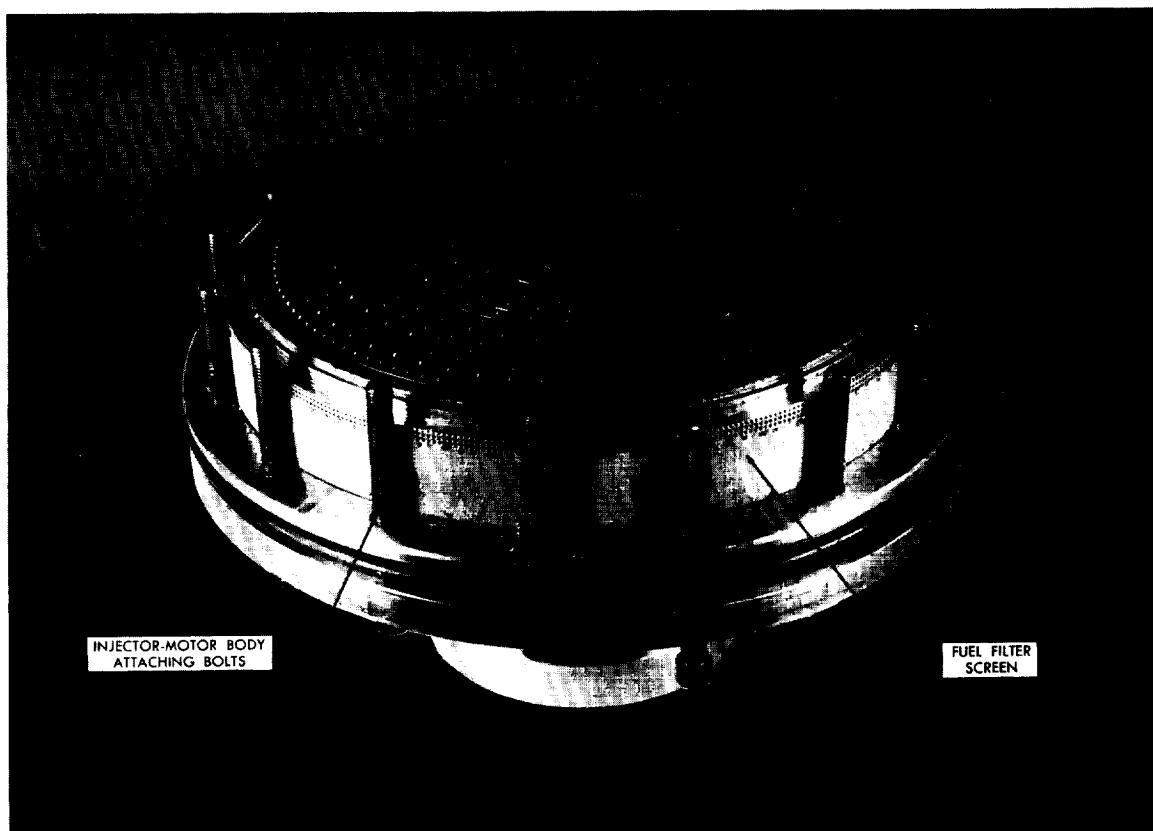
**Fig. 19a. First-Stage Injector Showing Typical Failure**

Due to these failures, all assembly and testing of production thrust chambers was discontinued, and a thrust chamber improvement program was implemented to obtain a precision injector and a reliable motor body. Fifteen injectors with six variations in design were tested during the period January to April 1957. Of all the injectors tested, only one did not score a

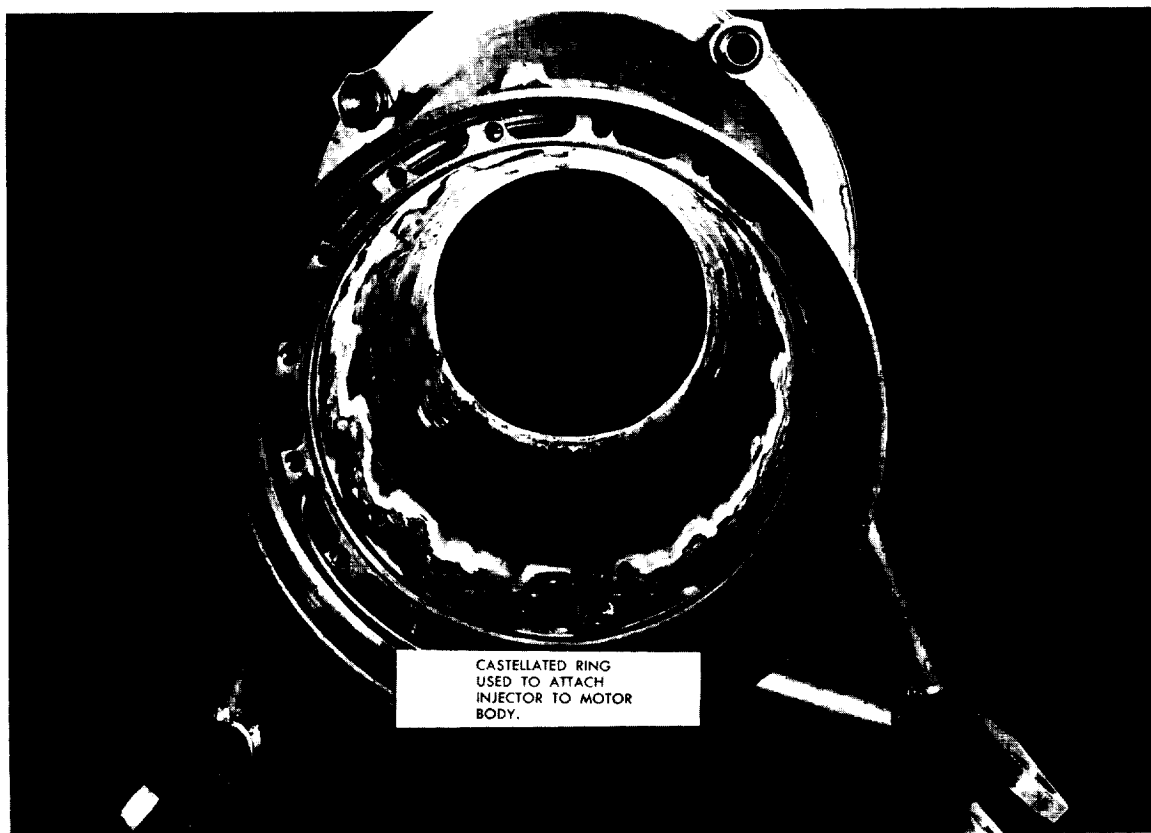
**Fig. 19b. Motor Body Showing Inner Shell Burnthrough**

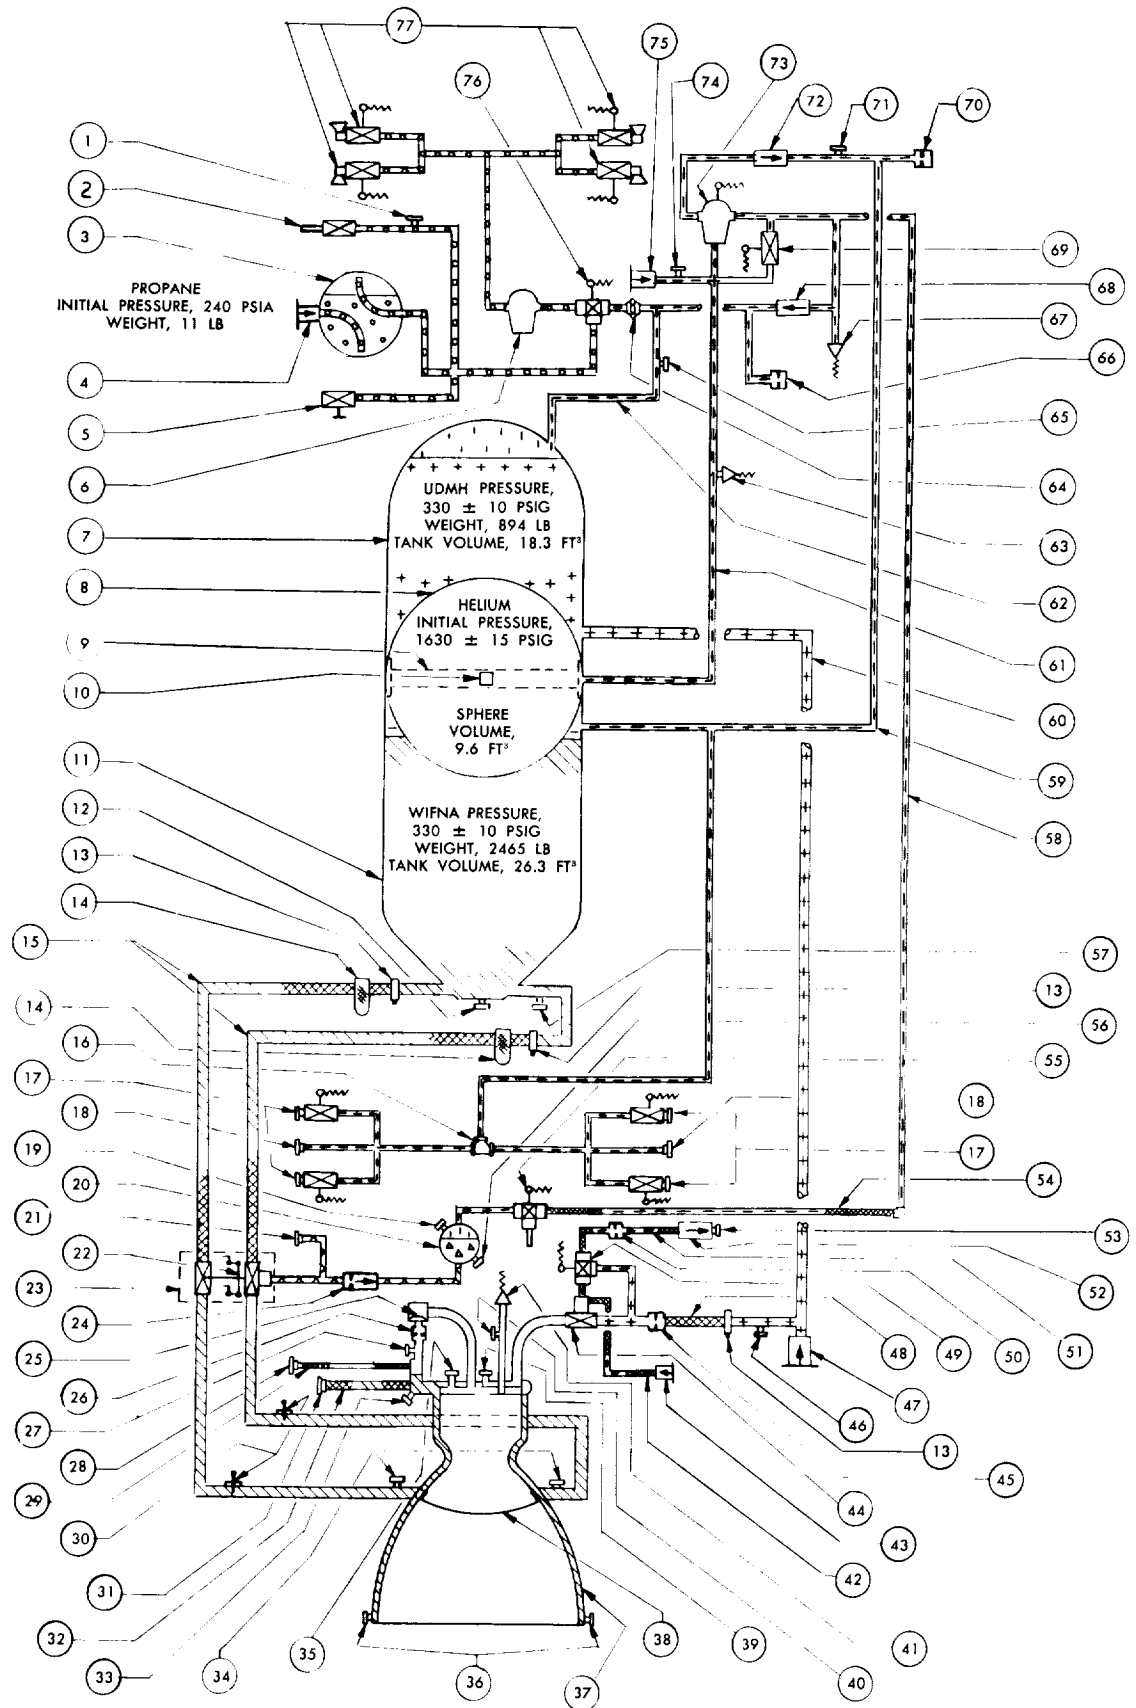
Fig. 20 Second-Stage Propulsion System Schematic

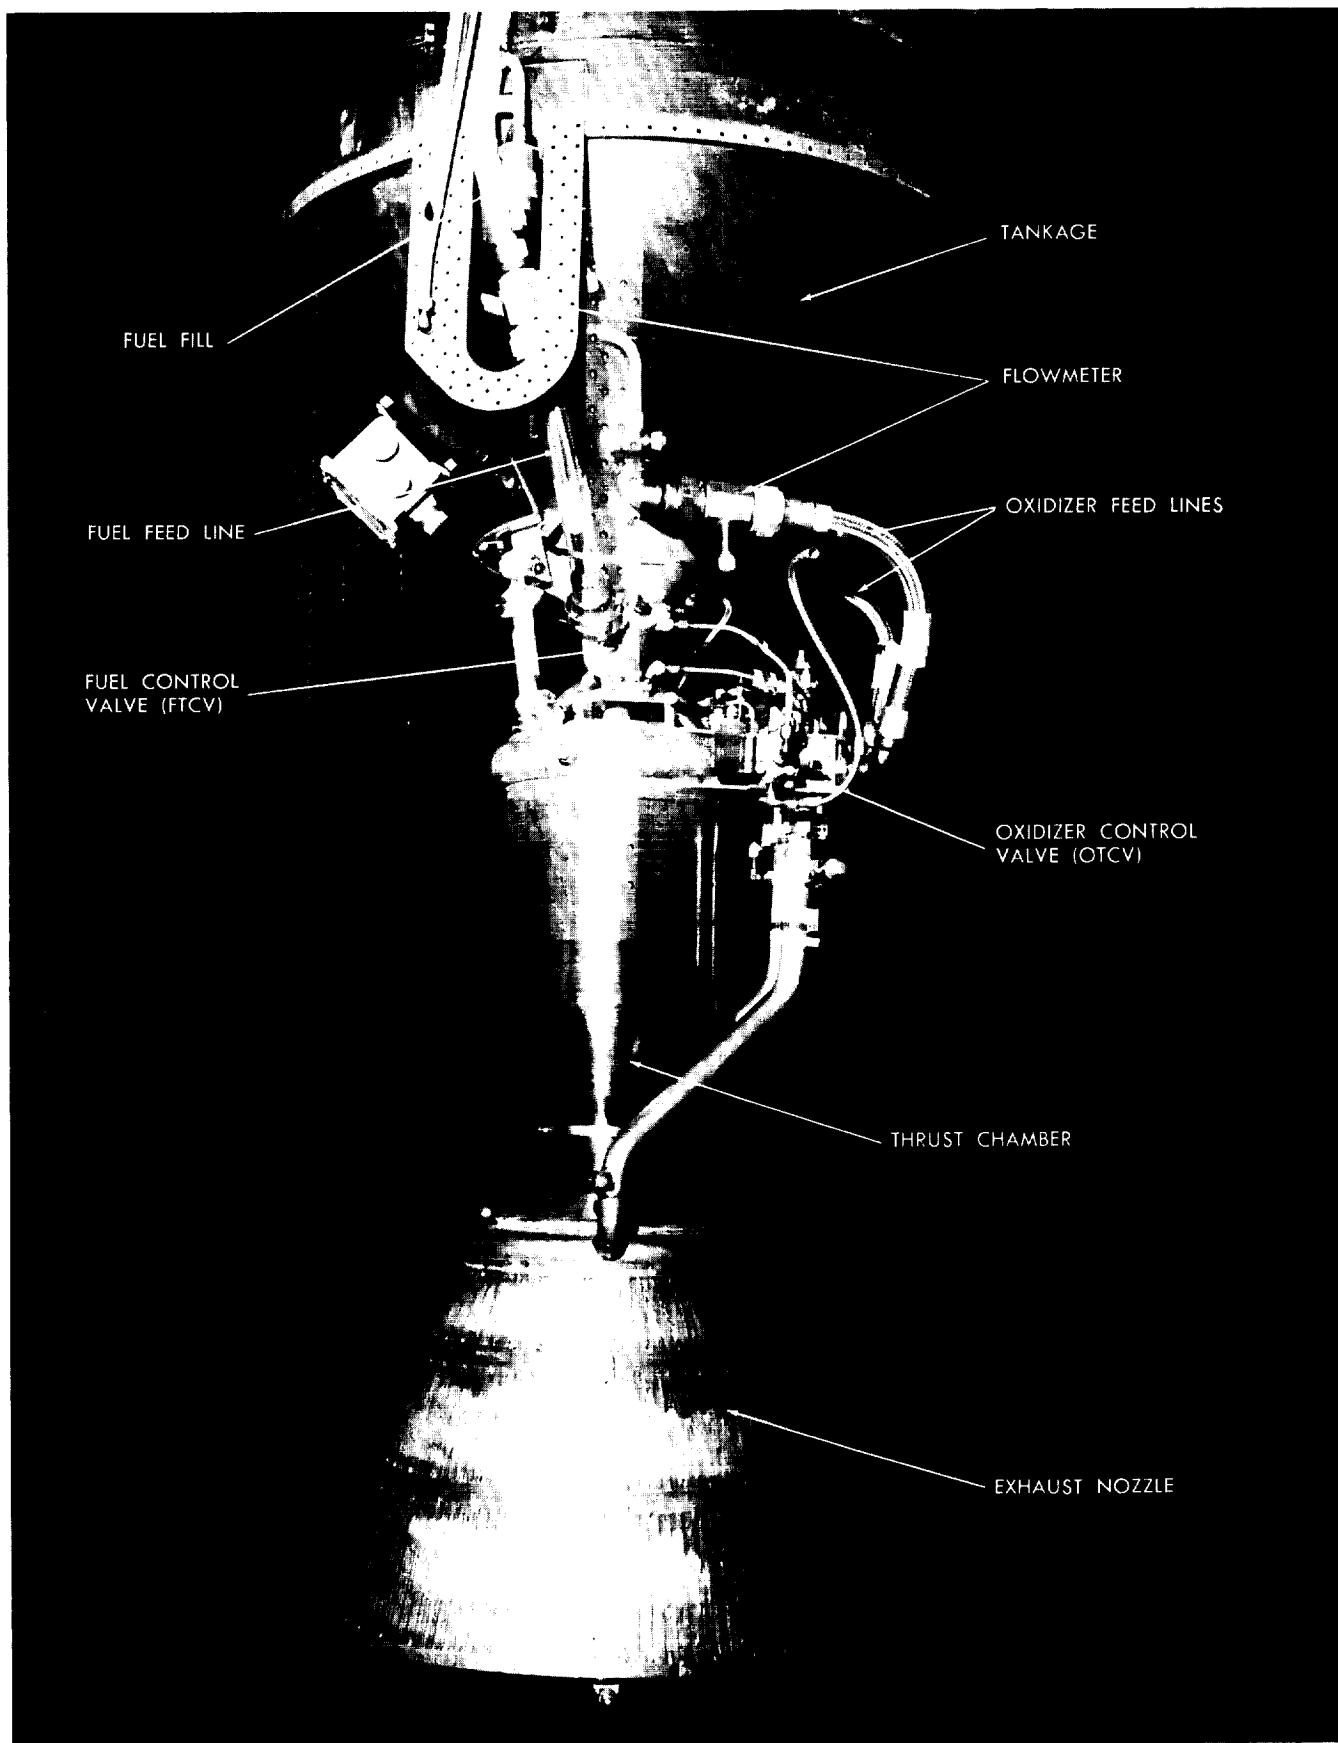
**Fig. 22 Second-Stage Engine Package**

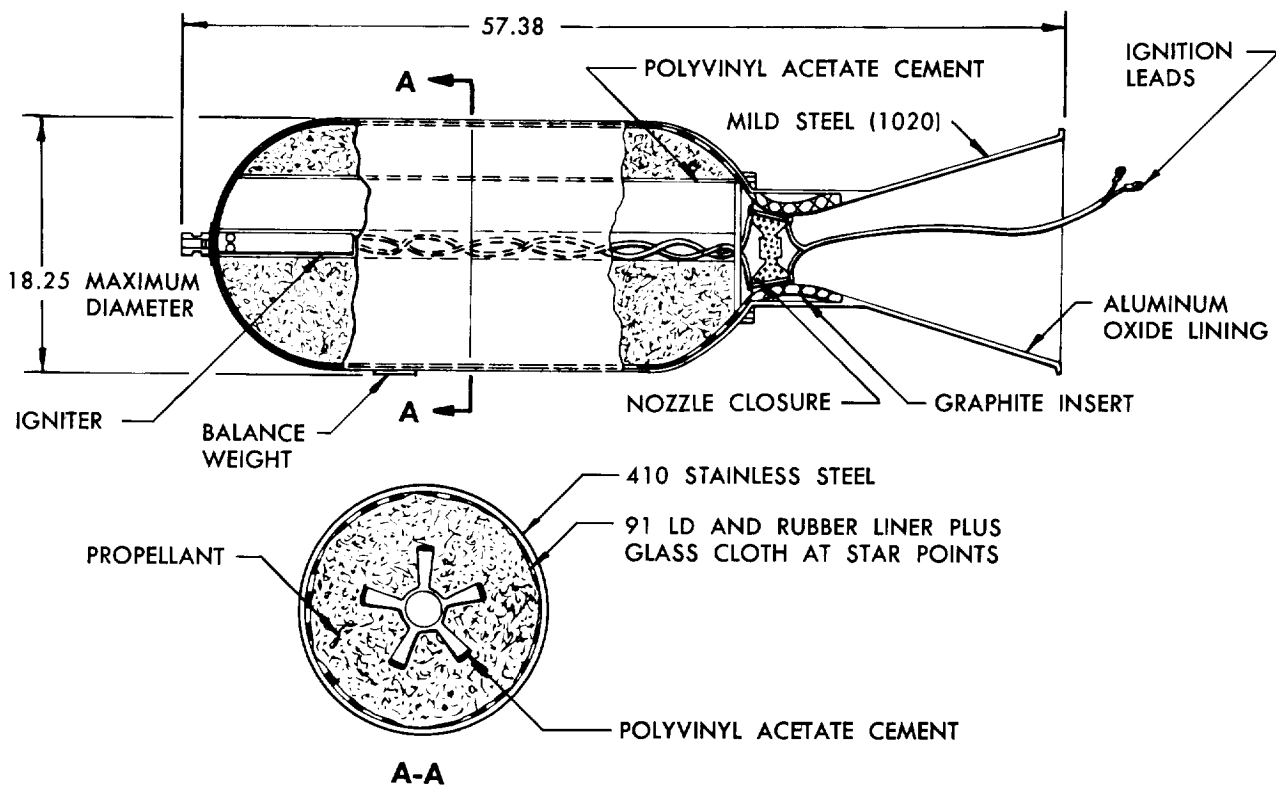
Fig. 26 Third-Stage Motor (33KS-2800) — Grand Central Rocket Company

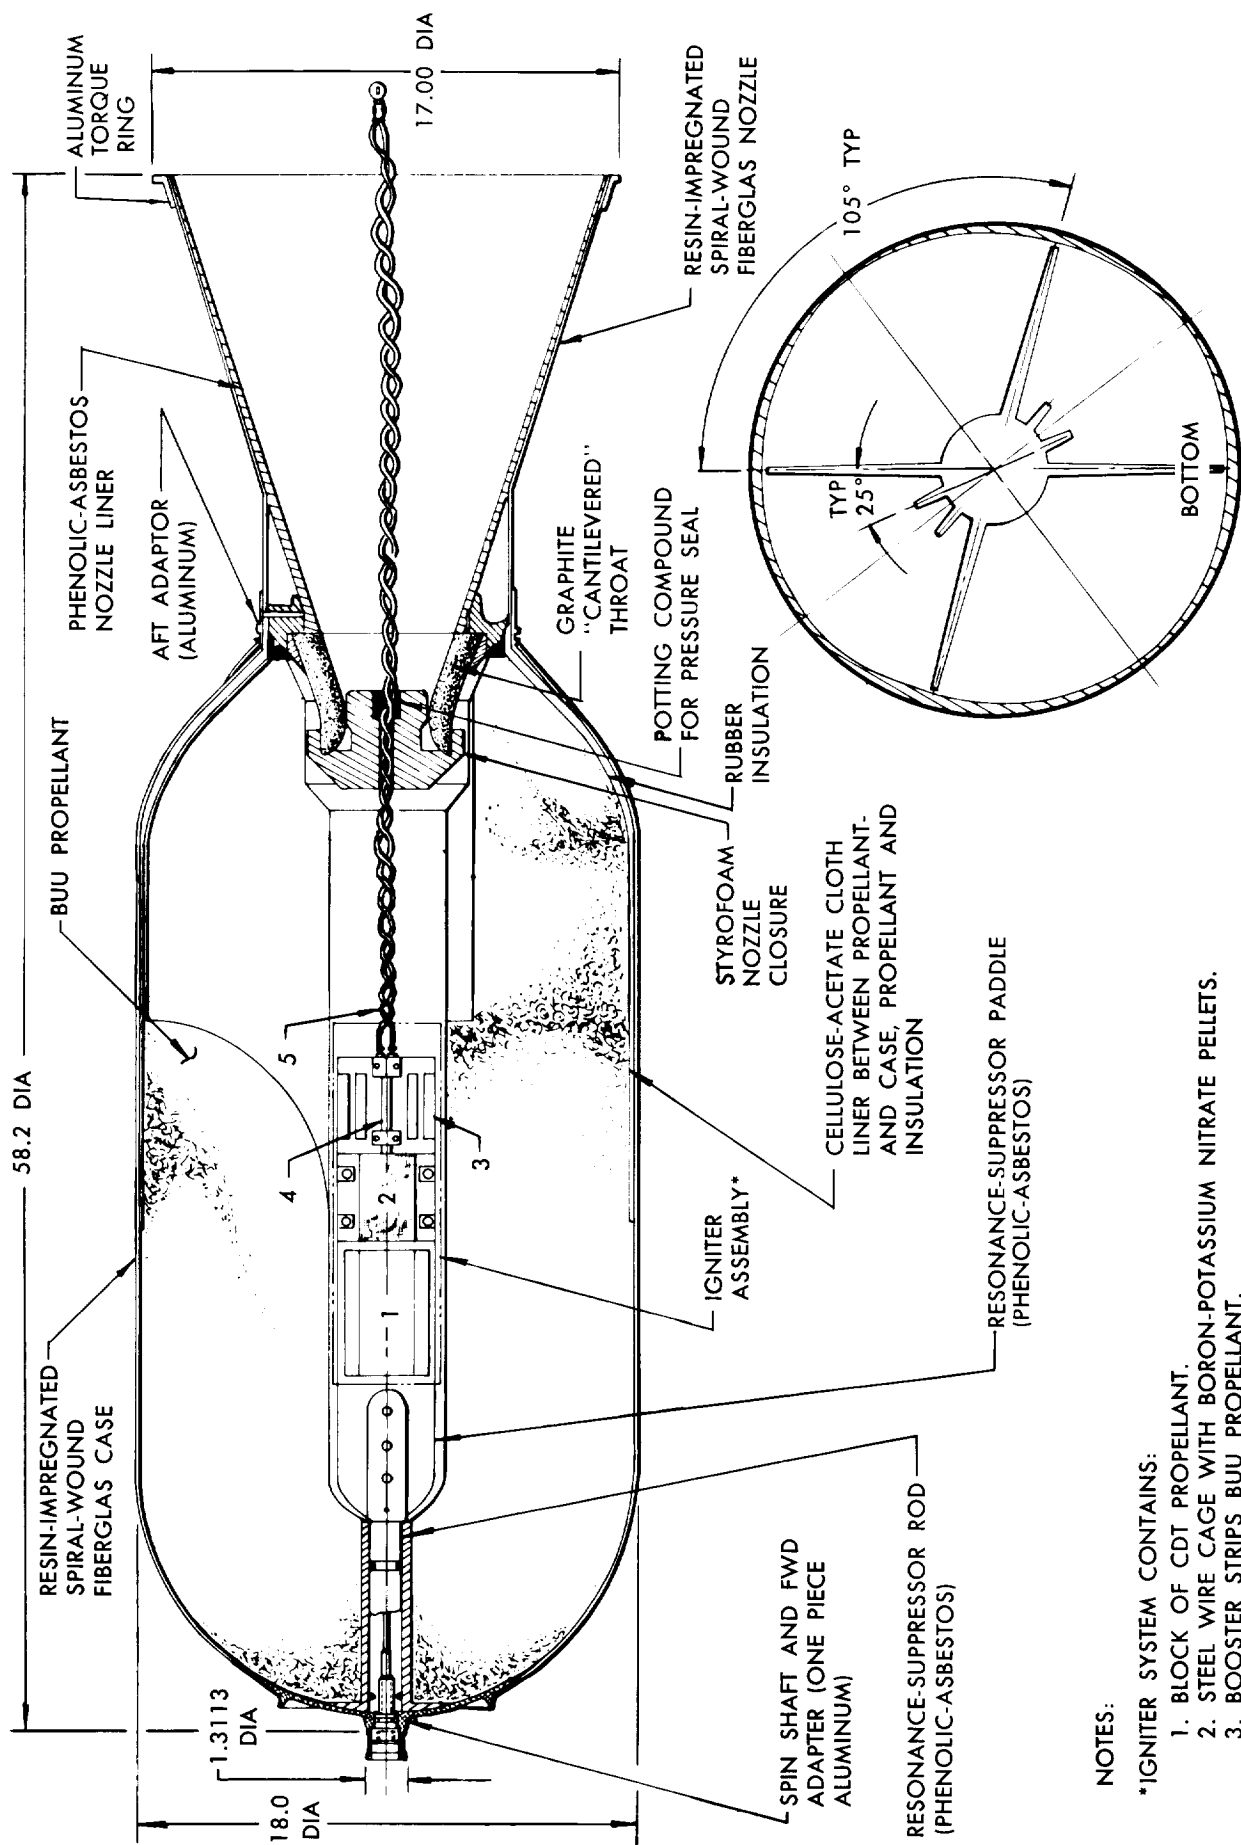
Fig. 27 Third-Stage Motor (38-DS-3100) — Allegany Ballistics Laboratory

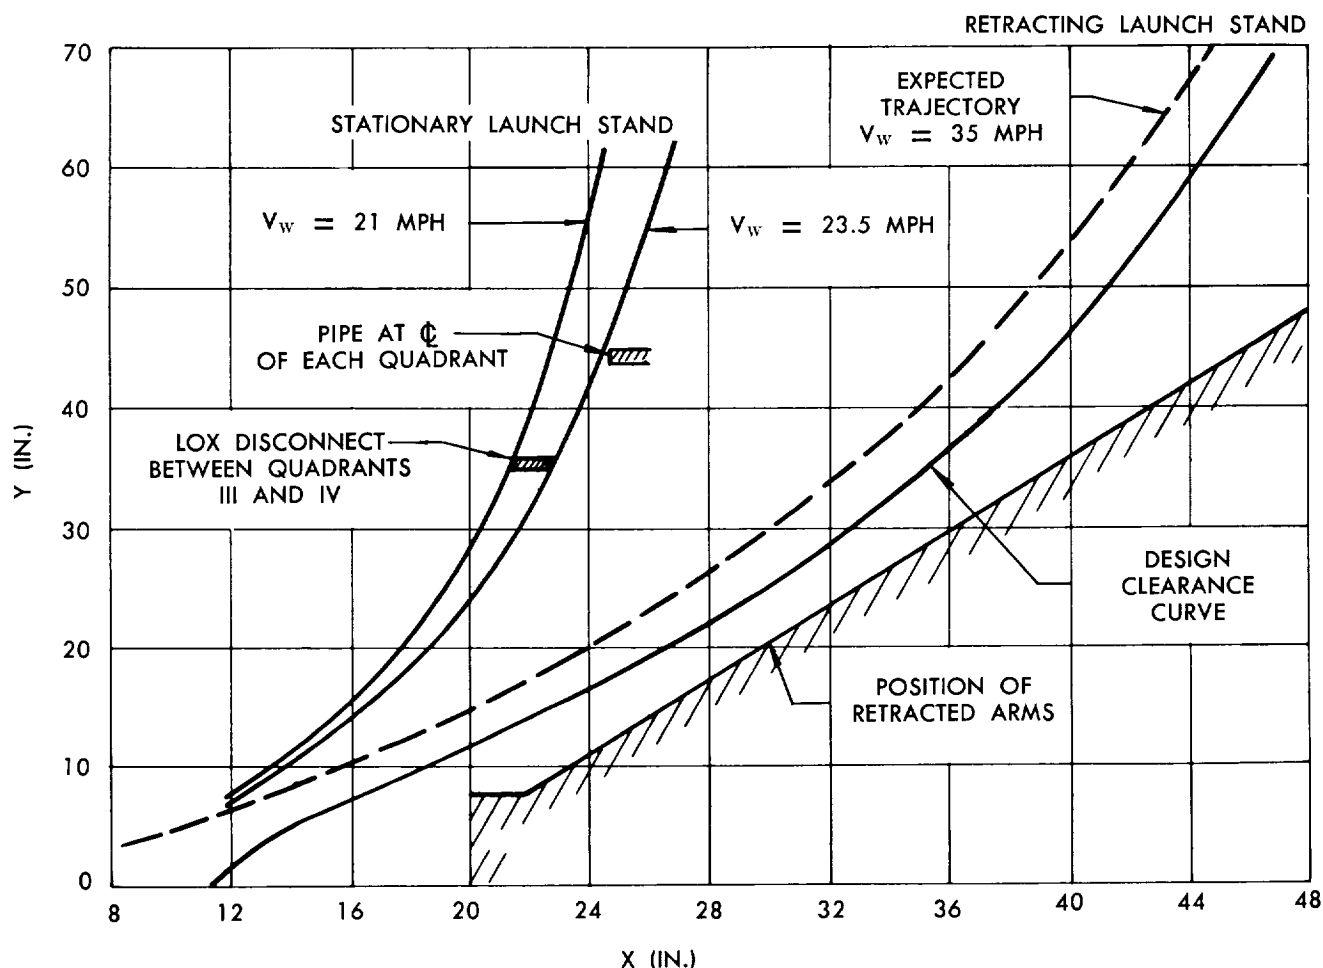
Fig. 28 Clearance Curves for Stationary and Retracting Launch Stands

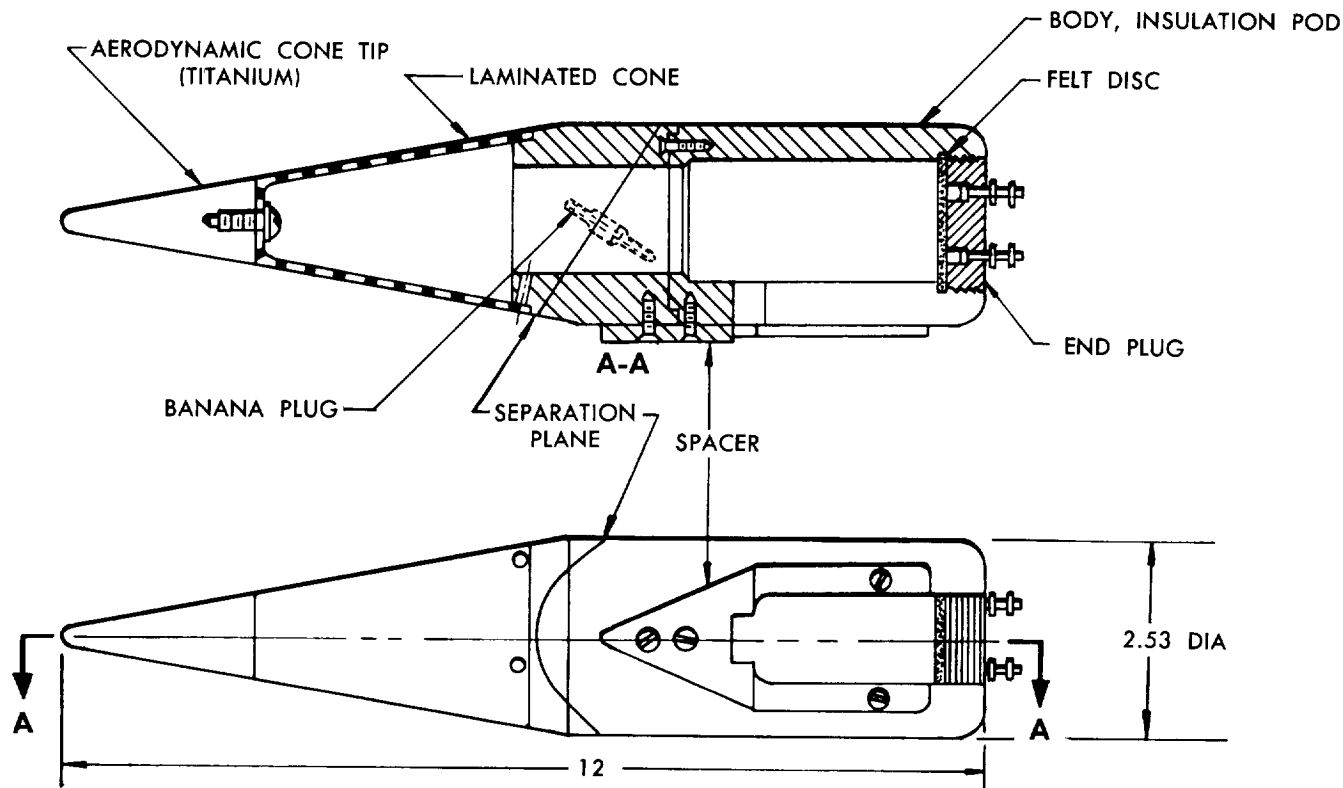
Fig. 30 Retrorocket Aerodynamic Cone and Insulation Assembly

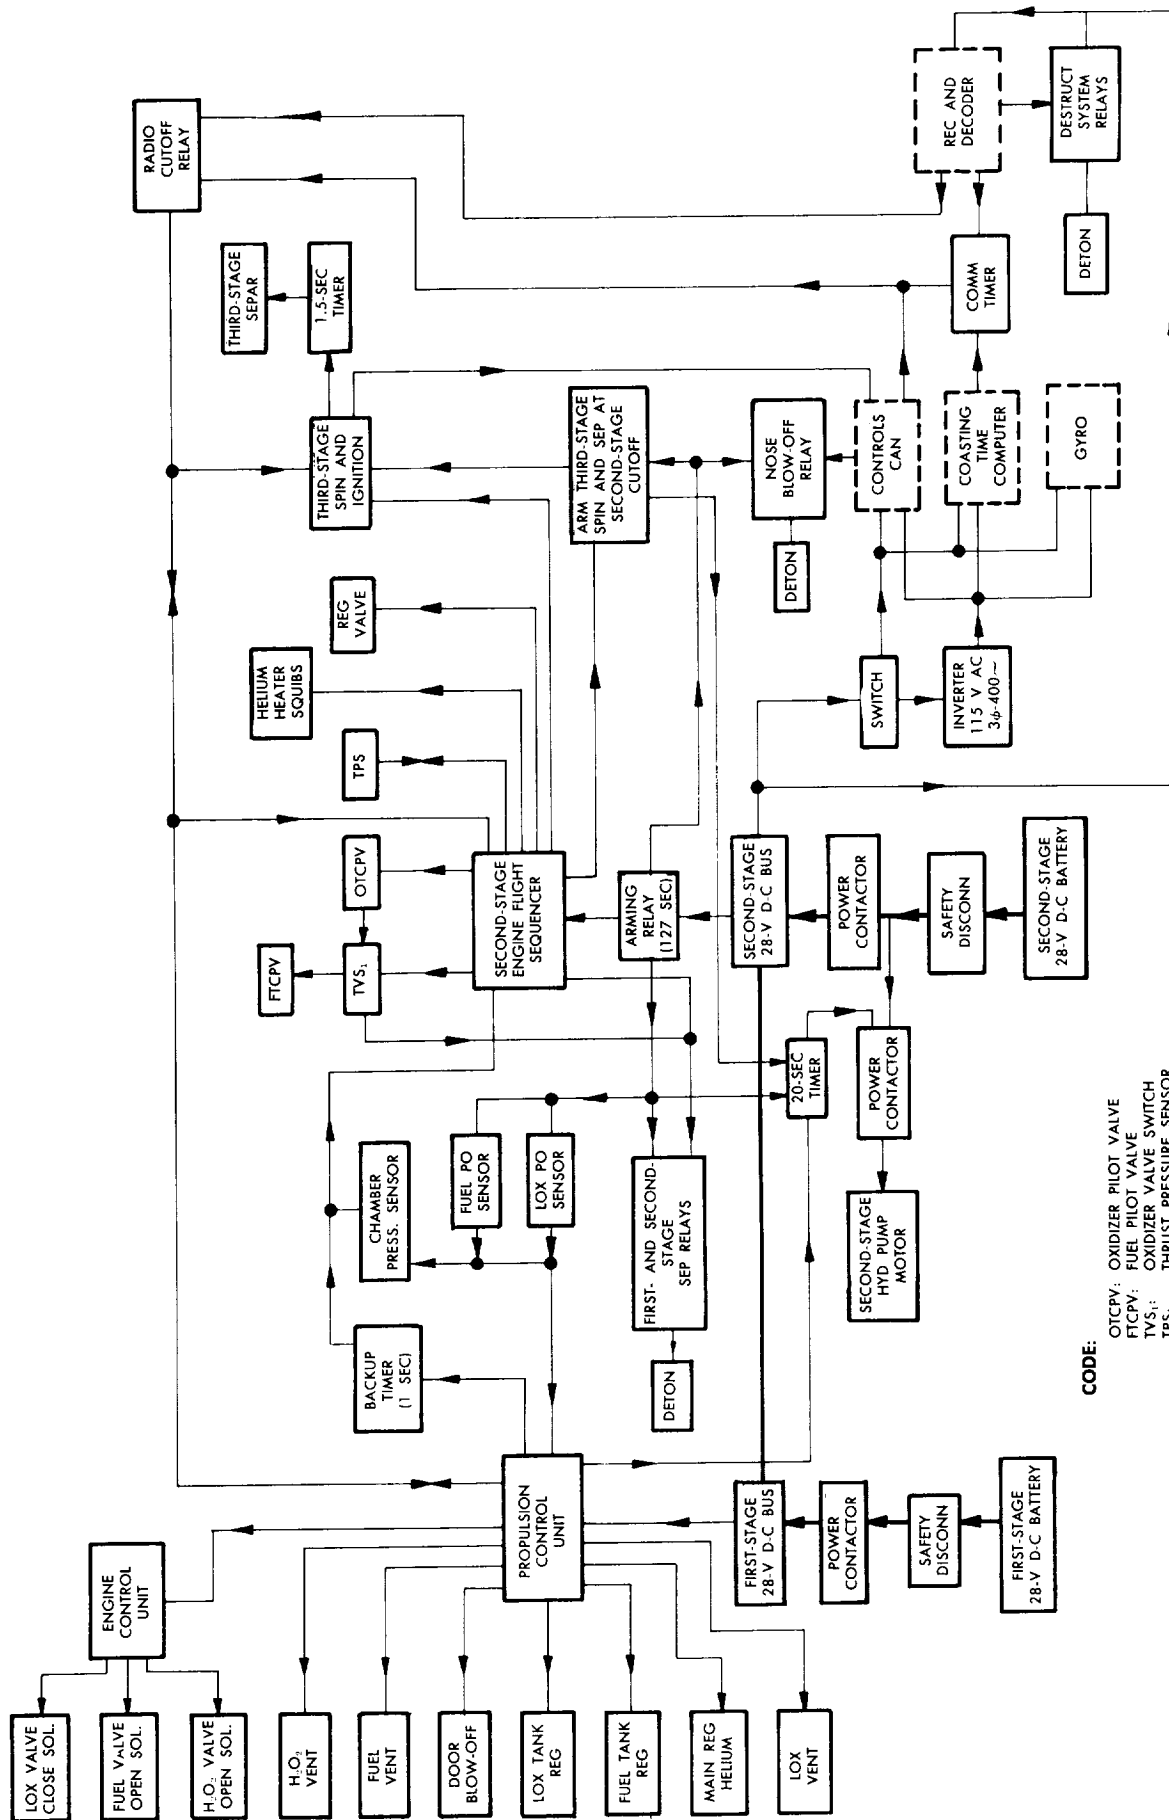
Fig. 31 Electrical and Engine Control Diagram
